Sea School of Newfoundland

S.V. Fiddlers Dream

**Survey prepared for Dr. Stephen Walker
January 9, 2011**

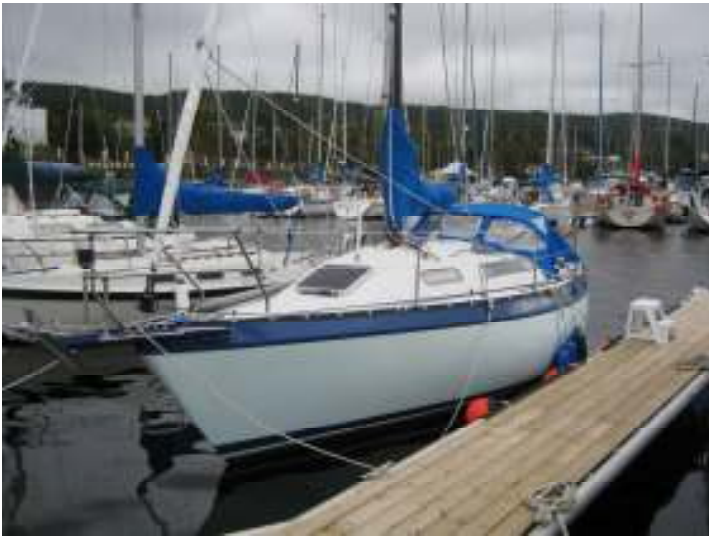
Bow profile

Length: 27' LWL: 23' 11"
Beam: 9' 04"
Draft: 5' 02"
Displacement: 6100 lbs
Material: Fiberglass
Watertight bulkhead: None
Condition: Above Average

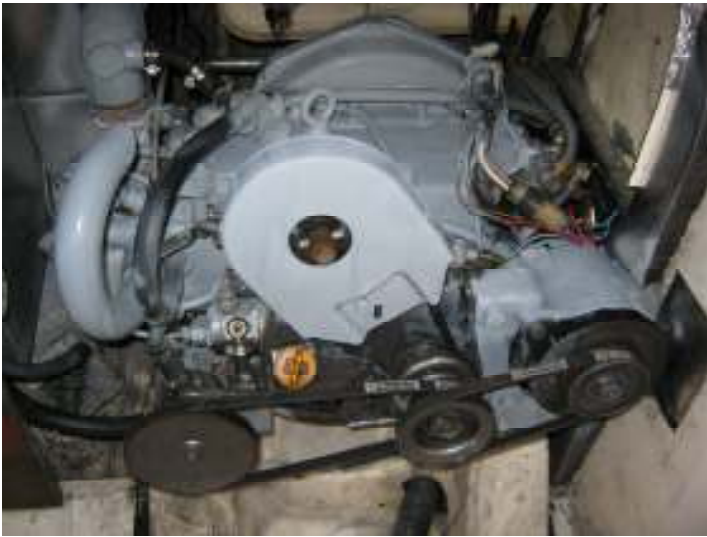
Gas or diesel:	Diesel
Manufacturer:	Yanmar
Model:	YSB 8
Year:	1977
Serial number:	Not visible
Horse power:	8 hp
Engine hours:	Unknown
Overhaul/maintenance:	Engine was reported to have been completely rebuilt by previous owner in 2004

Screw, diameter and pitch: 2 blade folding bronze prop; 13 X 10
 Propeller shaft: Stainless steel
 Stuffing box: Inside
 Cutlass bearing: On strut, replaced fall 2010
 Transmission: Yanmar supplied, type not visible
 Engine mounts: Average
 Propulsion system condition: Average, engine compartment well maintained and clean

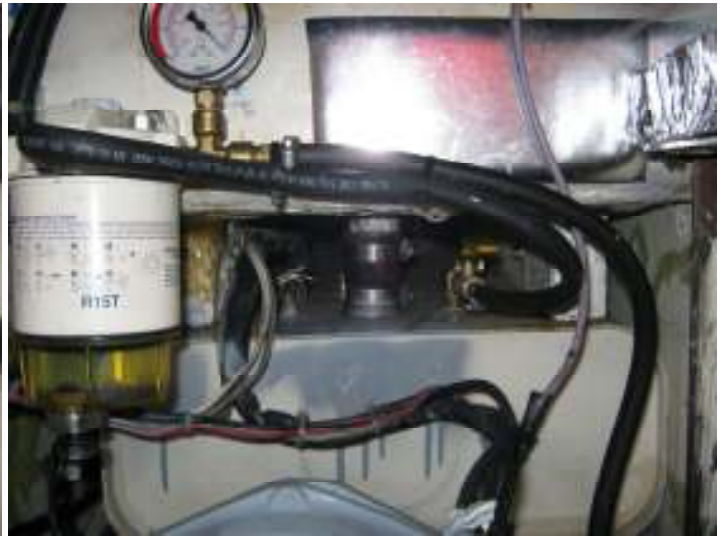
Carburation type:	N/A
Overflow collector:	N/A
Fuel tank capacity:	10 gallons
Tank material:	Welded steel
Tank valve:	Yes
Fill location:	Cockpit floor
Type of pipe:	Rubber
Overflow location:	Stern transom
Fill grounded:	Yes
Tank and pipe condition:	Above average

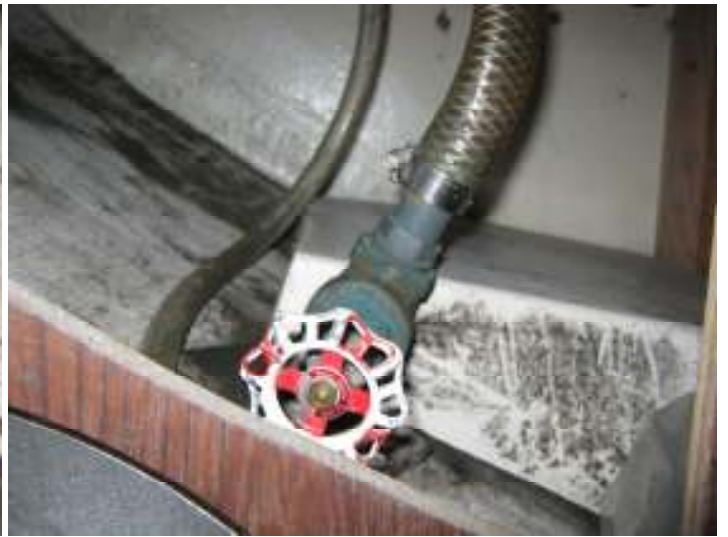
Engine sea cock

1.Ensure that all hose connections below water line are double hose clamped. Engine intake hose and head exhaust hose was found to be single clamped.

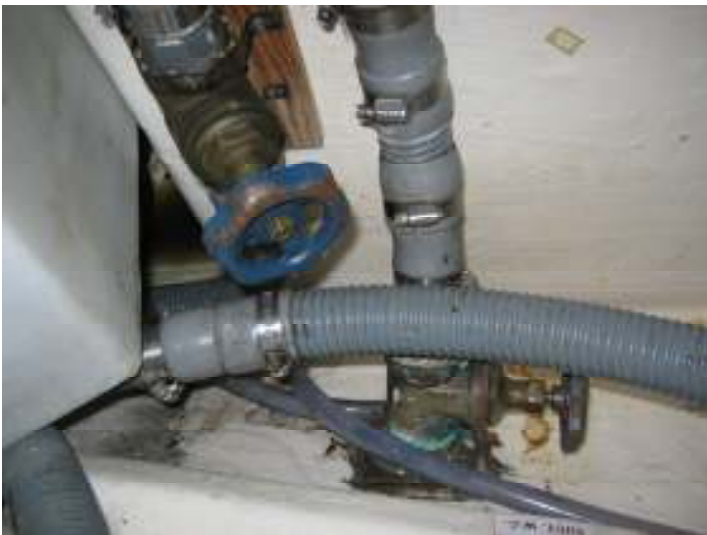
Sea cocks for head

USAGE	MATERIAL	VALVE	CONDITION
Engine	Bronze	Gate	Operational
Galley	Bronze	Gate	Operational
Head sink	Bronze	Gate	Operational

Head intake	Bronze	Gate	Operational
Head exhaust	Bronze	Gate	Operational

Replace sink hose for the head to one continuous hose, currently it is in two sections.

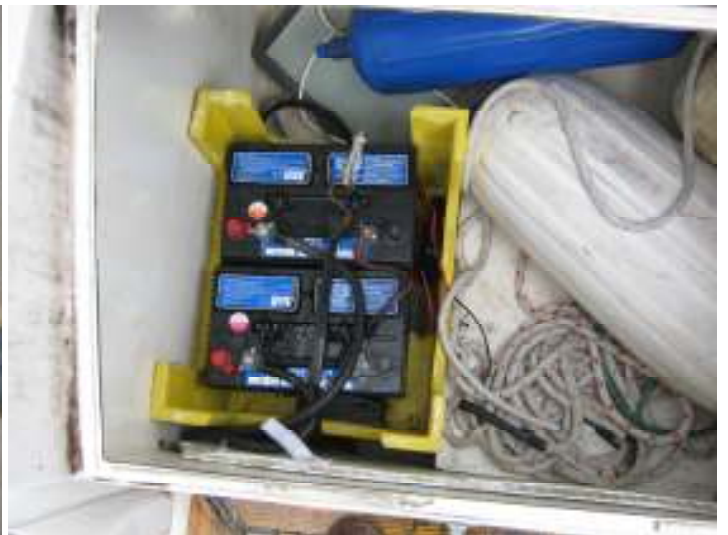
Battery box

Voltage:	12 Volt DC and 120 Volt AC shore power
Wiring type/rewiring:	Marine
Electrical panel:	At companionway
Shore power:	Yes
Main breaker:	Breaker system
Battery:	Lead acid, two
Battery containers:	Yes
Battery tie-downs:	Yes
Battery ventilation:	To starboard cockpit locker and overboard
Battery charger:	No
Hydro generator:	No
Electrical system condition:	Average
